13-04
Cabarrus County

August 27, 2003

Reference: **REPAIR OF 60-MIL HDPE LINER – INTERMEDIATE BERM
CMS LANDFILL V, CELLS 2C – 2D
Concord, North Carolina**

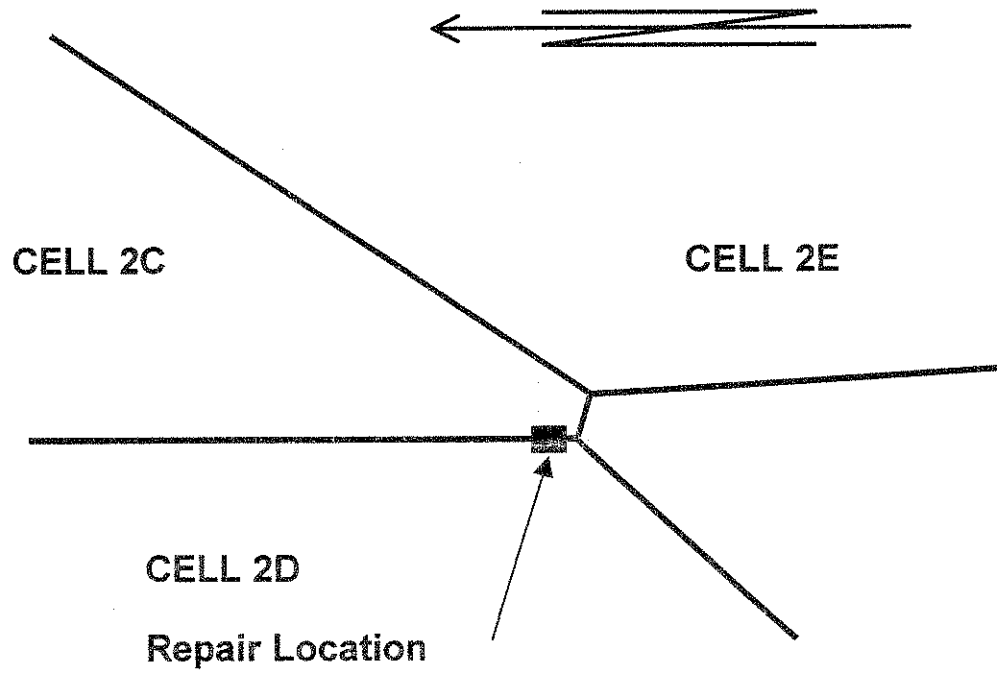
Figure 1 - Repair Location on Intermediate Berm

ESP Associates, P.A. (ESP) has completed the construction quality assurance (CQA) for a 60-mil HDPE liner repair located on the Cell 2C / Cell 2D intermediate berm approximately 35 feet north of the inside top crest of the perimeter containment berm. The damage and subsequent repair were both within the containment limits of Landfill V. The intermediate berm liner serves to segregate leachate from an active cell from stormwater from a non-active cell footprint and to segregate leachate between individual cells. The repair was made by GSE on August 15, 2003 under the full-time monitoring and inspection of ESP. The attached Figure 1 shows the location of the repair.

BFI personnel assisted GSE to appropriately expose the damaged liner area. GSE obtained textured 60-mil HDPE from surplus material left on-site from Cell 2L construction. The Cell 2C / Cell 2D intermediate berm liner is a 60-mil smooth HDPE with white surface. GSE prepared the area by drying and cleaning and cutting the damaged area from the liner. A patch measuring 4.5 feet X 6.5 feet was cut from the textured HDPE and heat bonded into place. The edges where the patch meets the parent 60-mil liner were ground in preparation to receive an extrusion weld.

The patch was installed using extrusion welding techniques installing a HDPE resin bead at the intersection of the patch and underlying parent liner. Welding was performed under the

monitoring of ESP personnel. Following installation of the patch, the weld was vacuum box tested revealing no leaks.
